Shamley Village Green Pond Scoping Assessment and Management Recommendation

14th May 2020
For: Shamley Green Parish Council

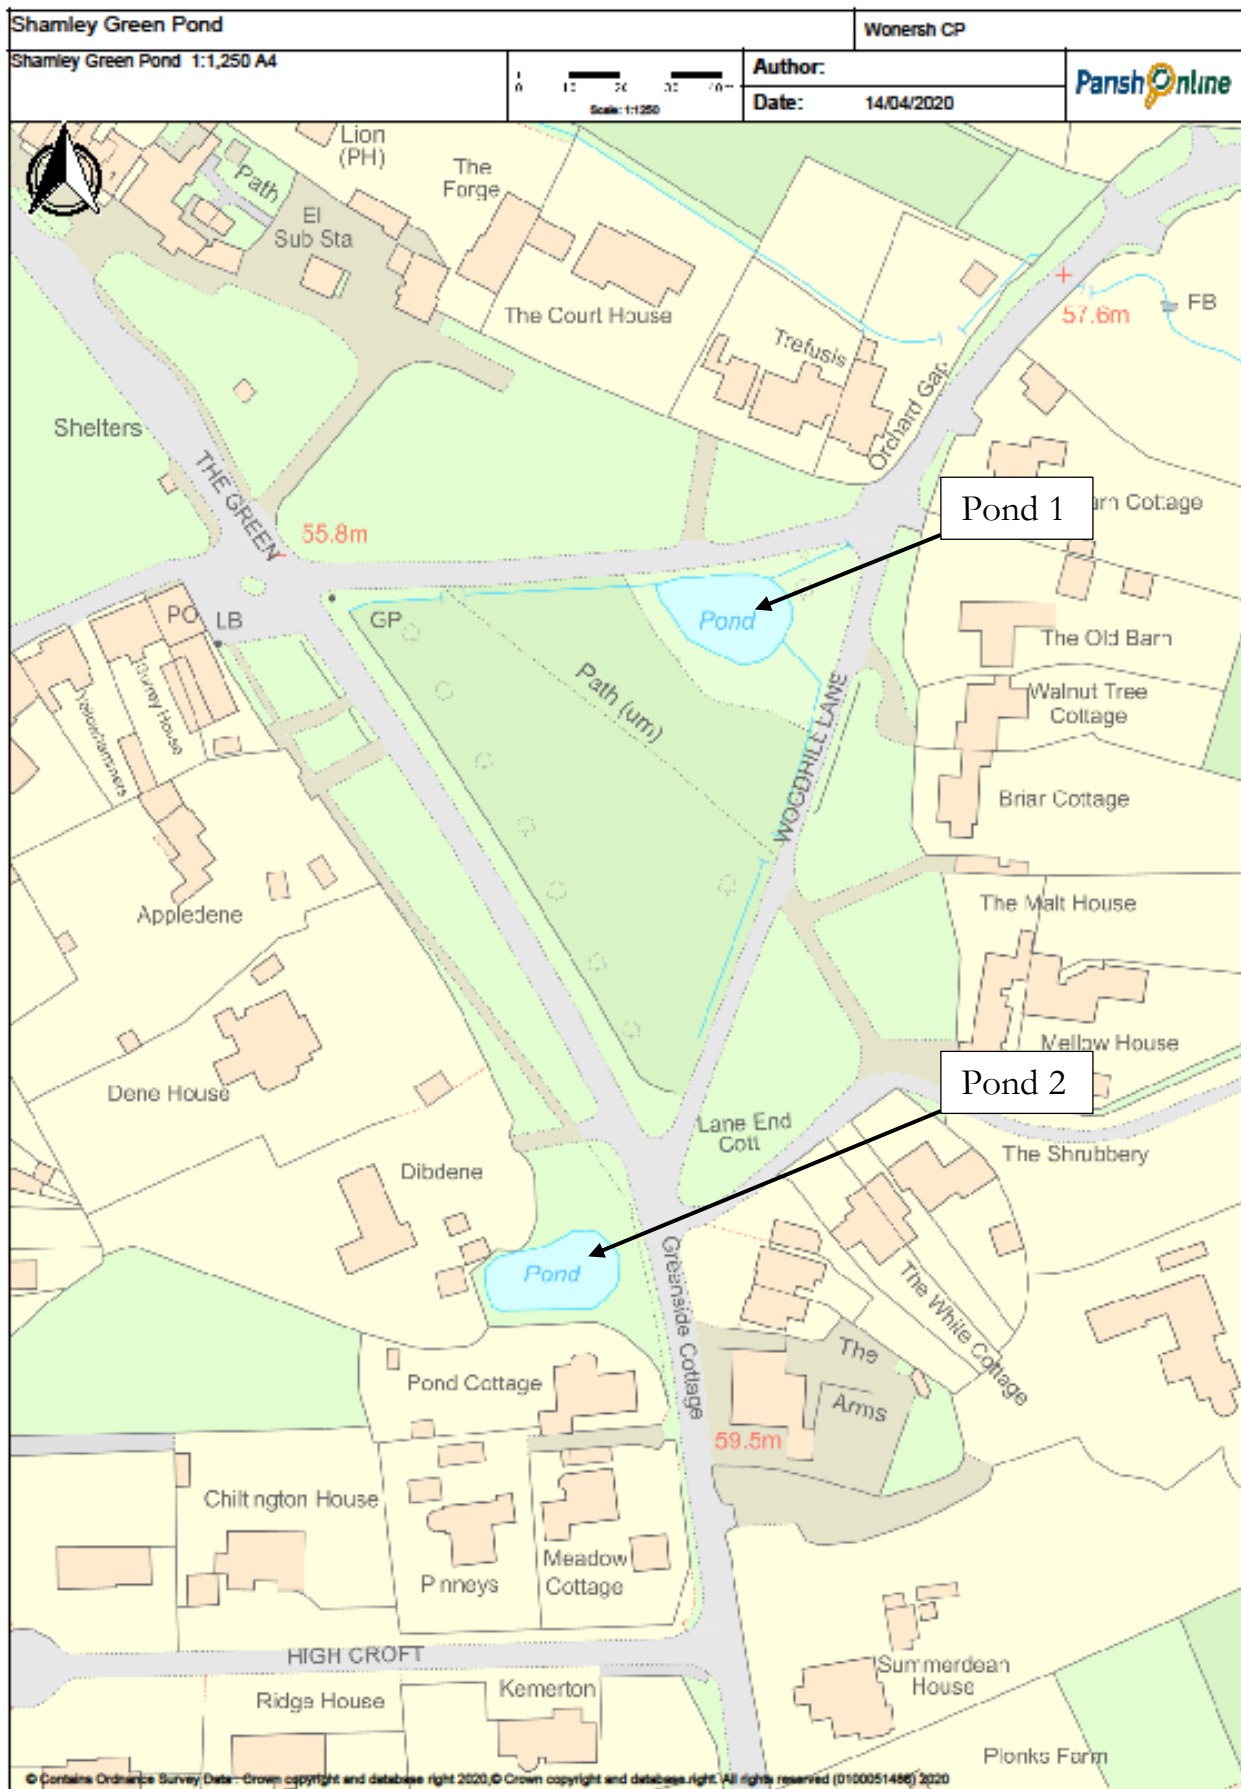
Figure 2: Location of Shamley Green Ponds and Ditches

A Phase 1 habitat survey was conducted at the two ponds (see **Figure 2**) on 17th April 2020. Lamping and 25 bottle-traps (15 in Pond 1 and 10 in Pond 2) were deployed during the survey visit, with newts caught release between 6 to 7am on 18th April 2020. The ponds were assessed for its Habitat Suitability Index (HSI, Oldham et al 2000¹), a useful tool to determine suitability to support GCN. The HSI index scores a pond as 0 (unsuitable for GCN breeding) to 1 (ideal for GCN). On the morning of 18th April observations were made on birdlife associated with each pond.

3.1 Habitat Assessment - Pond 1 was within open semi-improved grassland, with willow *Salix-Rubus* bramble scrub along the southern banks, road along the north side and a mature willow tree just east of the pond. The pond supported New Zealand Stone-crop *Crassula helmsii*, with a 100% cover across the pond surface. Native flora, such as marsh marigold *Caltha palustris* and willowherb *Epilobium* spp. had less than 1% cover across the pond, with a duck-house and willow-scrub on an island in the centre of the pond. The pond has an inflow and outflow, with pendulous sedge *Carex pendula*, rushes *Juncus* spp. and water-cress *Nasturtium officinale* growing in the outflow ditch.

Pond 2 was located on the roadside opposite Bricklayers Arm, with two gardens directly on the western boundary and a narrow road verge to the east. The pond support New Zealand Stone-crop *Crassula helmsii*, with a 100% cover across the pond surface. A yew-hedge *Taxus baccata* and wall is located along the southern boundary and laurel *Prunus laurocerasus* with a mature lime *Tilia* spp. tree. Alder *Alnus glutinosa*, elder *Sambucus nigra* and bramble grew on the eastern boundary having recently been felled, with wood-chip covering the bankside. The pond margin supported rushes, with water mint *Mentha aquatica*, reedmace *Typha latifolia* and bur-reed *Sparganium* spp. An outfall was located in the south-west corner of the pond.

1. Ducks should not be encouraged at this pond, as wildfowl will encourage the spread of stonecrop to other ponds.
2. The pond is shallow and a sump could be dug (by mini-digger) in the middle of the pond, to create a deeper area with more permanent water.
3. Pond 1 did not appear to support any significantly important ecological features and therefore could be considered for filling-in with a new pond dug, for example further south and in the middle of the Green. Pond 1 could be infilled with arising from the new pond. If this is considered the flora of the Green should be surveyed to determine the conservation status of the semi-improved grassland and a hydrological assessment considered to ensure any new ponds created will hold water.

1. Scrub around the pond had been coppiced with chippings spread across the bankside. While it is recommended that shrubs are coppiced on a regular basis all chippings should be chipped and removed offsite – for example chipping could be taken to a nearby allotment sites, if allotment-holders are interested in using the chippings on their plots. If the chippings are left *in situ* they will leach nutrients into the pond.

2. Macrophytes had recently been removed and as reedmace can grow several metres a year, it is recommended that the pond is cleared of macrophytes on a biannual or annual basis keeping plant cover to a maximum of 20-30% cover across the pond. This could potentially be carried-out by hand, using local volunteers, with vegetation left to breakdown on the road verge just north of the pond. Although wood-chippings should not be left nearby to the pond, it is recommended that macrophyte vegetation is left nearby, to allow aquatic-life to return to the pond.

3. The outflow in the south-west corner of the pond should be kept clear of vegetation and a cofferdam could be created around the outfall to maintain a higher water level.

4. The removal of cherry-laurel and bamboo on the north-west boundary with the property at Dibdene would benefit the biodiversity of the pond, if they were replaced with an alternative native hedge (such as a yew-hedge).
