WORKS ON THE SHAMLEY GREEN DUCK POND AND THE BRICKLAYERS POND

MANAGEMENT OF SHAMLEY GREEN PONDS IN THE VICINITY OF THE GREEN – JULY 8TH 2020

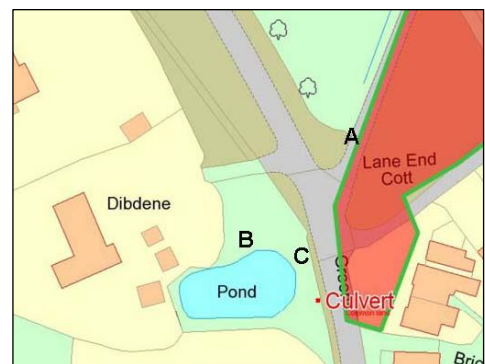
The bamboo will be cut initially to 3 feet from the edge of the pond. The bamboo will be cleared to ground level. With the assistance of the owner of Dibdene we can then investigate and agree a practical boundary line to which the cut area will be adjusted. With the agreement of the owner bamboo adjacent to the boundary will be topped at about 5 feet to reduce shading of the pond. Ed Carpenter recommends that regular cutting of the bamboo shoots in the cleared area will progressively weaken the root system. To prevent further incursion from Dibdene a slit trench adjacent to the boundary, to the depth of the root system, kept clear, should be sufficient.

The digger will be delivered by low loader at an early hour (6.30am?) to minimise traffic disruption. The vehicle will enter area A, the digger will be offloaded and driven across the road to area B. The low loader will be reversed onto Guildford Road. The digger will be on site for one day only and removed by a reverse operation.

The removed material will be piled in area C, giving wildlife an opportunity to return to the pond. A grab lorry from a waste disposal operator will be parked on the Guildford Road to collect the material; but this should take less than 30 minutes at a time of low traffic, directed by Stop/Go signs past the lorry.

Overgrown laurels are all rooted within Dibdene and will be cut to the boundary. They will quickly grow new foliage. A chipper and open truck for removal of wood and other chippings will be parked in area B. Some protection for the grass surface will be laid; but it is expected that the area will be damaged to some extent, the digger referred to below will be operating on the pond perimeter. Any damage will be repaired.

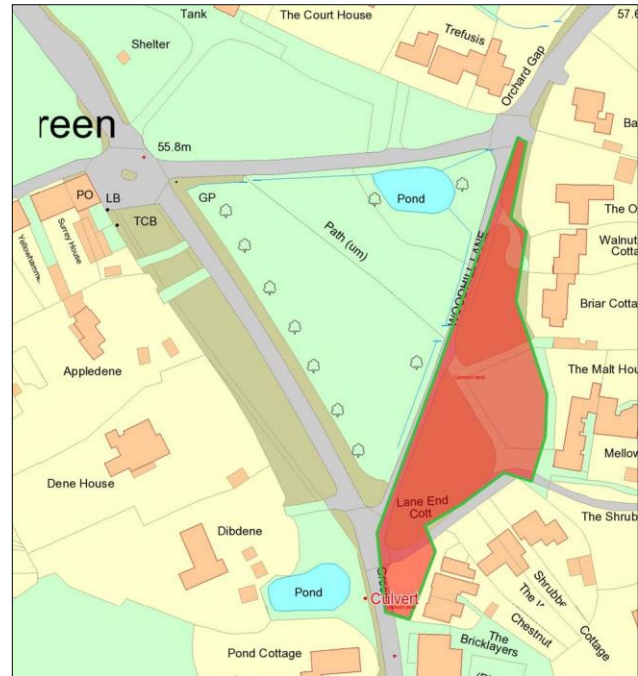
The two remaining ponds are the Duck Pond, the upper one on the map, and the Bricklayers Pond. The latter was in a typical location to benefit horses on an exit route from the Village and opposite the stables associated with the Bricklayers inn.

In 1900 there were four ponds in the vicinity of the Green. Two were filled-in in 1948 as part of the “tidying up” after the War, one was outside the Old Malt House and the other at the entrance to Hulmead.
